Bulletin of the Archaeological Institute  
of the Republic of Indonesia

**NEW LIGHT ON SOME  
BOROBUDUR PROBLEMS**

**By : Soekmono**

## NEW LIGHT ON SOME BOROBUDUR PROBLEMS

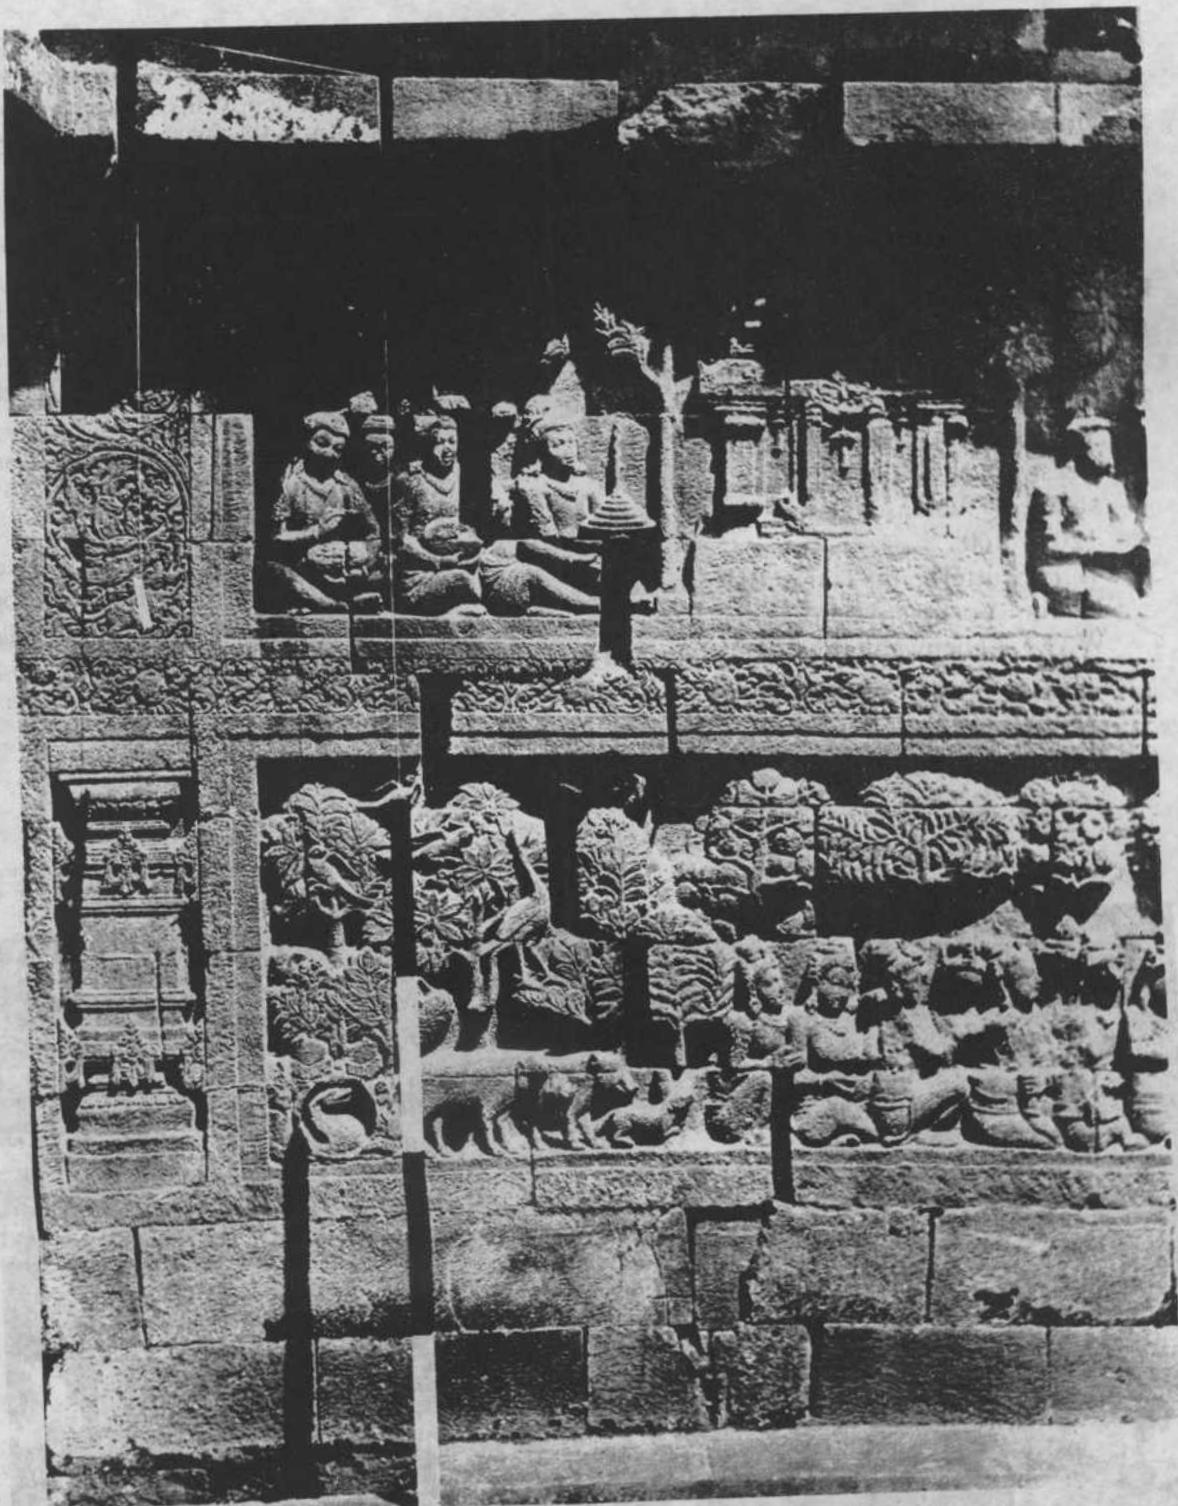
First gallery of the main wall. Widening of the joint  
(Photo Arch. Inst.)
